# Foster

## Case Study: Mold Gets 10 Years to Life

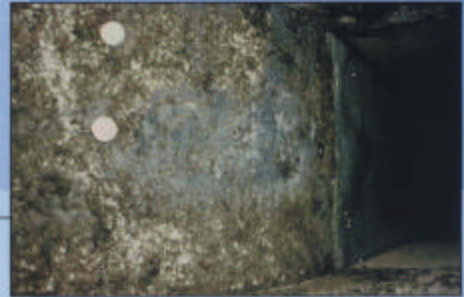
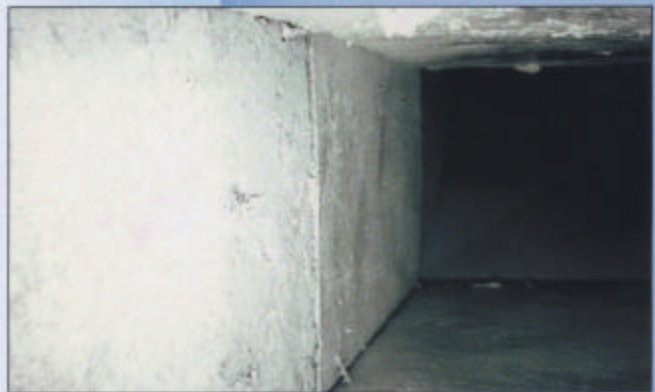
Prior to application of Foster 40-20 fungal wipe samples on the fibrous glass duct liner showed average fungal levels of 45,000 colony forming units per square centimeter (cfu/cm<sup>2</sup>).

Foster 40-20 Fungicidal Protective Coating was applied to the ductwork in February 1993. Since then, the ventilation ductwork has been inspected and tested for fungi at one, three, five and ten years after the initial application of Foster 40-20. Fungal testing and visual observations have confirmed that no growth of fungi has occurred in the ductwork coated with Foster 40-20. In areas where the ductwork remains un-coated, testing and observations revealed continued significant fungal growth.

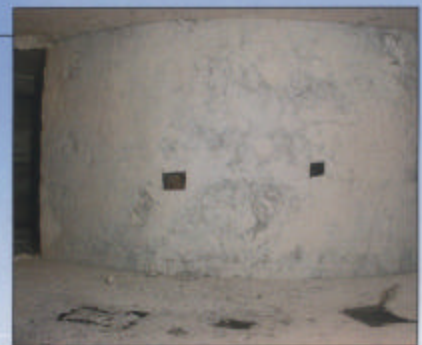
After ten years the fungal wipe samples on the same areas showed an average of 7 cfu/cm<sup>2</sup> -meaning no growth!

After ten years, the ductwork coated with Foster 40-20 looks as good visually as when it was originally applied. The warden at the prison is extremely satisfied with the results of the Foster 40-20 solution. His experience with fungi at the prison has led him to take a proactive approach concerning the indoor environment. The well-being of his staff, guards and inmates is always his first priority.
